**B4380 Buildwas  
Speed Management  
Feasibility Report  
March 2017**

**Report Reference: 1076162**

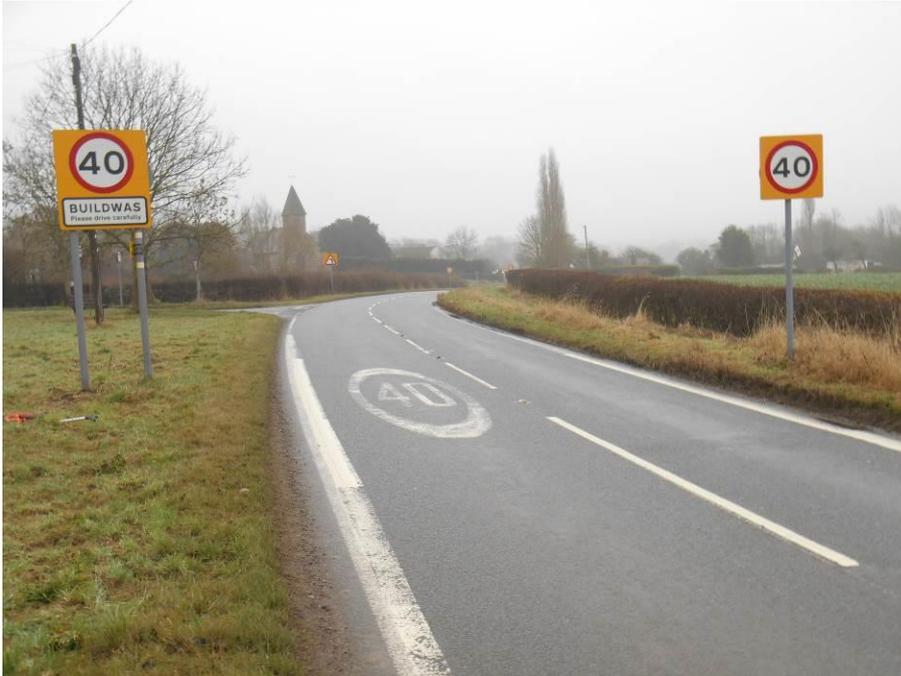
**Photo 1** – Start of 40mph buffer zone. View towards Ironbridge Bypass.  
The spire of the village church is visible in the distance.

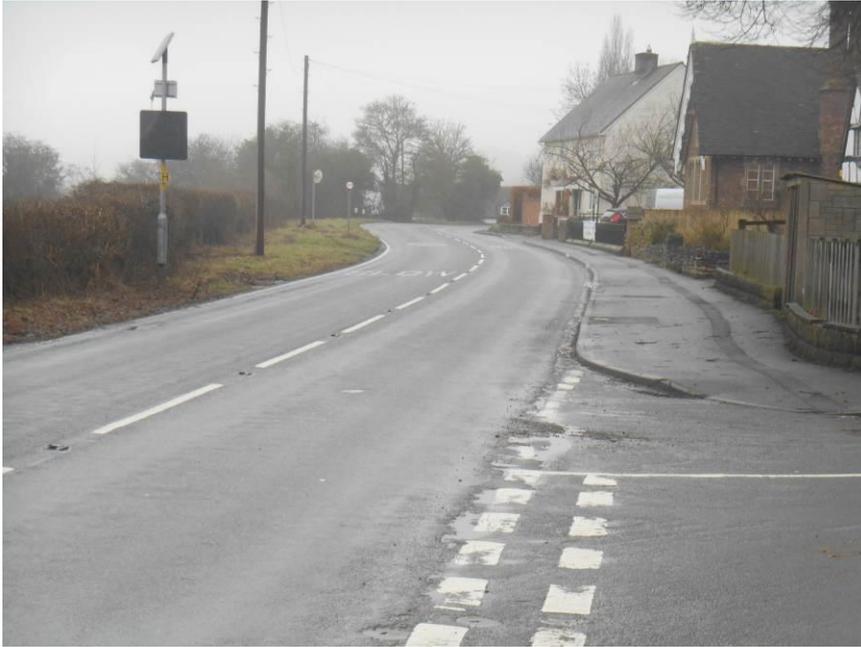
**Photo 2** – Area within 30mph speed limit (view near village school in westbound direction towards Shrewsbury). The village school is the brick building on the right of the photo. Note VAS sign opposite and the presence of frontage development on one side of the B4380 only.

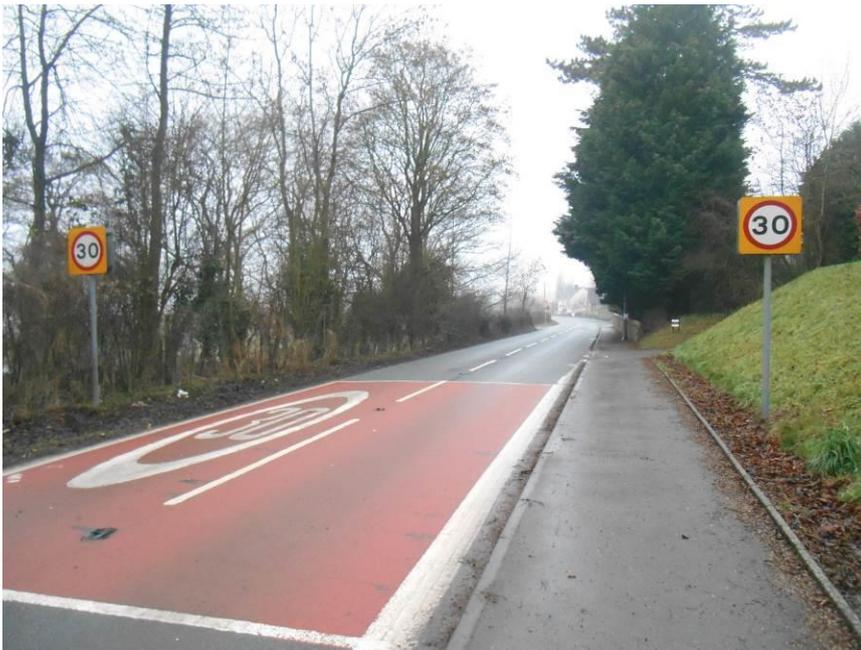
**Photo 3** – Easternmost 30mph Gateway area – view in direction of Shrewsbury

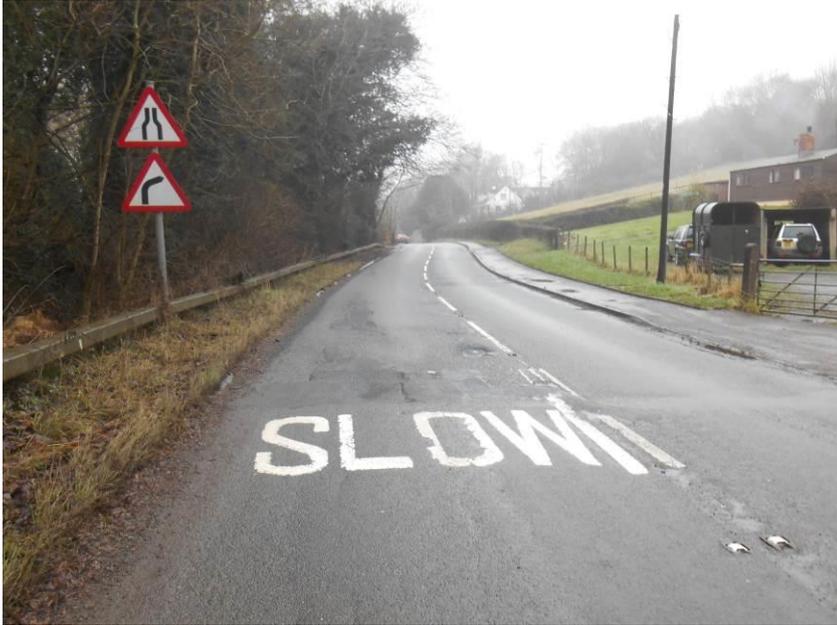
**Photo 4** – Section of easternmost 40mph buffer zone. View in direction of Shrewsbury.

- 3.4 The short 30mph zone only requires one 30mph repeater site between the terminal signs to comply with the spacing guidance outlined in Traffic Signs Manual Chapter 3. This is satisfied with a double faced repeater sign opposite the school, however existing signs which could be used to mount further repeater signfaces have not been used for this purpose (eg.warning signs in Photo 4 for 40 mph repeaters).

- 5.6 If the 30mph limit is to remain an enhancement of the signing is possible by providing additional 30mph repeaters mounted on existing warning signs.
- 5.7 The opportunity should also be taken to replace the missing 40mph repeater in the easternmost buffer zone to ensure compliance with TSM Chapter 3 guidance.
- 5.8 The existing Vehicle Activated Sign (VAS) could be changed to a back to back updated '30/ Slow Down' speed display as indicated below, to address eastbound speeds as well as the existing westbound.

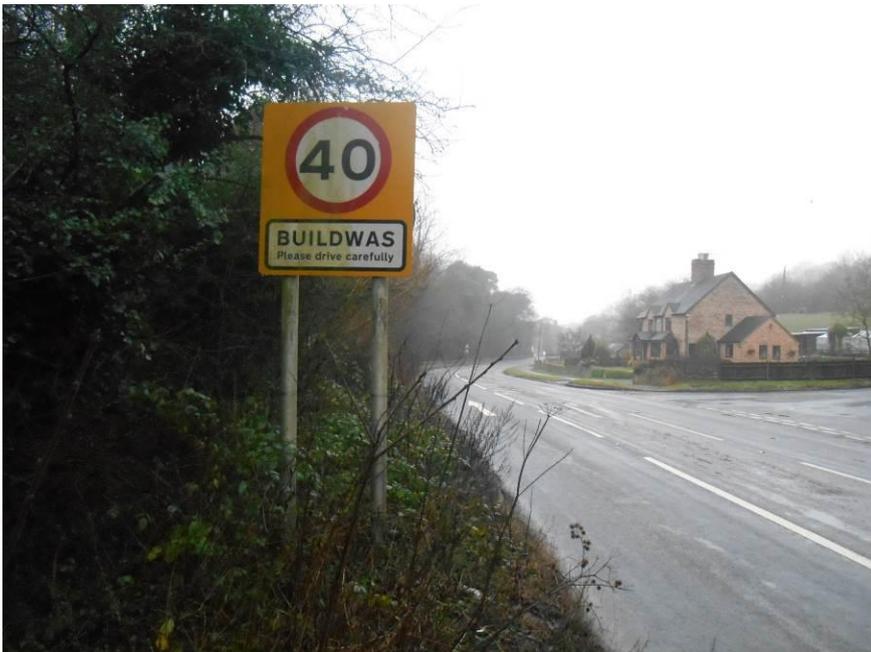
**Photo 5** – Start of easternmost 40mph buffer zone. View in direction of Shrewsbury.

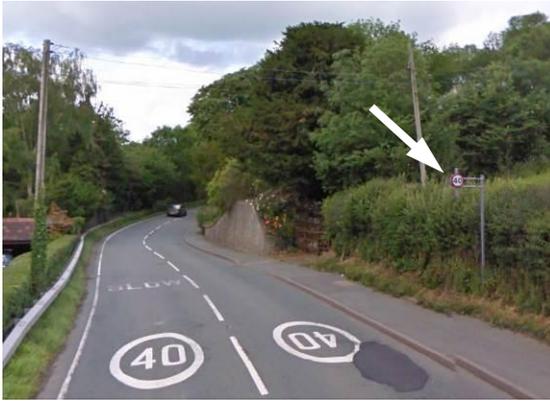
- 3.8 Reference to Google Streetview (Photo 7) shows that in 2011 there was a repeater sign present approximately 220 metres from the terminal signs which would have complied with the guidance. In January 2017 (Photo 8) this did not appear to be present.

**Photo 7** – 40mph repeater sign present on the right in easternmost 40mph buffer zone (June 2011).

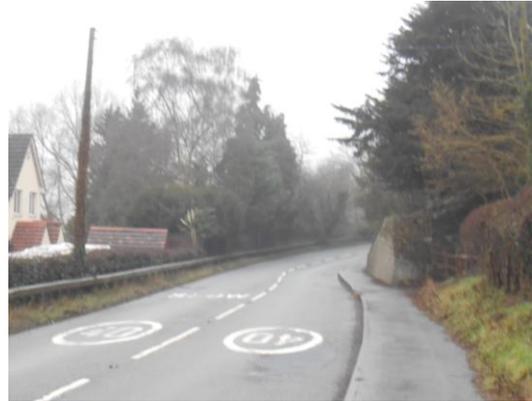
- 3.9 The absence of the repeater sign may have a marginal effect on increasing the westbound entry speeds to the 30mph zone although the carriageway roundels are still present.

**Photo 8** – Same location Jan 2017.

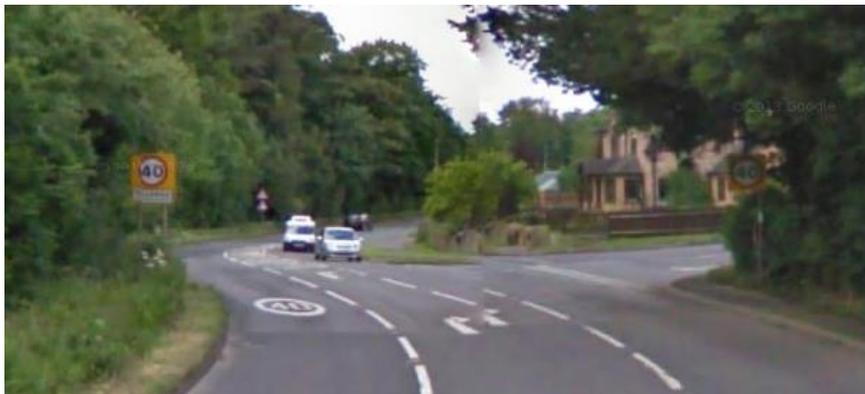
- 3.10 The existing easternmost 40mph terminal signs are not clearly visible as they are positioned under overhanging canopy of trees (Photo 9), this may impact on the lack of speed reduction after leaving the Ironbridge bypass.

**Photo 9** – Easternmost 40mph terminal signs under overhanging tree canopy.

- 5.10 The relocation of the easternmost 40mph terminal signs of approximately 30m towards the Ironbridge bypass will enable them to be seen more clearly by drivers.
- 5.11 Also a Glason 'Gateway' panel or similar incorporating the village name could be positioned near the relocated terminal signing, on one side of the carriageway only, to alert drivers entering the village (Photo 11).

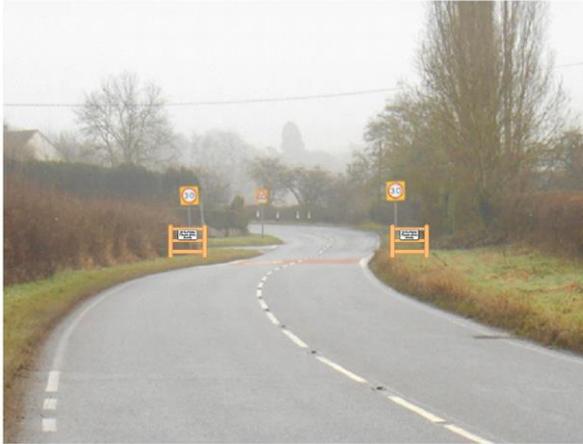
**Photo 10** – Possible gateway treatment at western entry to 30mph speed limit area

- 5.9 The verge width available on the western 30mph Speed Limit Gateway is sufficient for Glason 'Gateway' panels or similar to be sited on both sides of the carriageway.

The provision of these would harmonise with those being considered for Leighton, a village on the same route approximately 1.5 miles to the west and at the nearby village of Eaton Constantine. See photo 10 below.

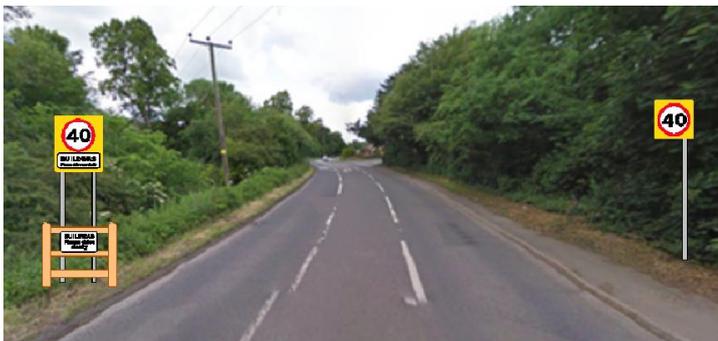
**Photo 11** – Relocation of terminal signs and Gateway panel incorporating village name.
